# BMW 1.5L (B38) GDI Engines

## Fuel System Service

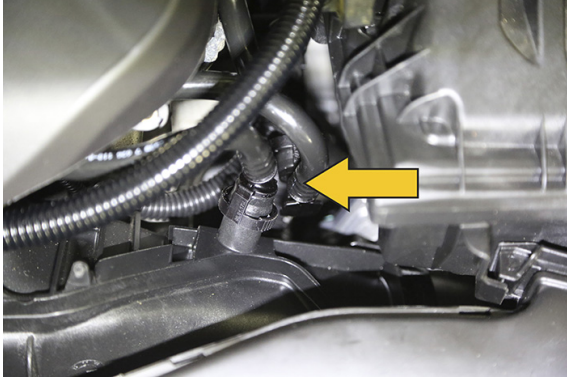
4. Verify the Intake Adaptor is tightly attached to the supply hose.
5. Locate and remove vacuum line just behind the throttle body.

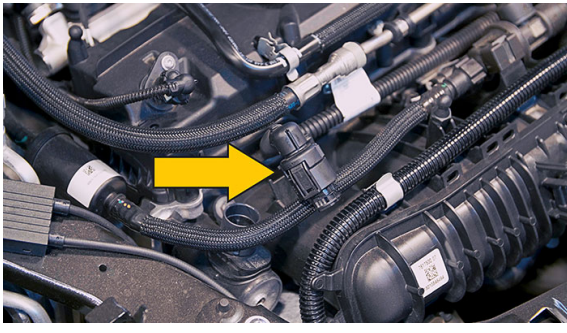
6. Use a shop towel to remove any oil residue from inside the vacuum line port.
7. Insert adaptor into the open vacuum port.
8. Locate and disconnect the Valvetronic actuator.

10. Open ball valve on supply hose.
11. The adaptor will administer 11 oz. of cleaner in 20-25 minutes depending on engine vacuum. When supply tool is empty, close ball valve and allow the engine to idle for 15 minutes.
12. When supply tool is empty, close ball valve and turn engine off.
13. Remove adaptor and reinstall vacuum line. Reconnect the Valvetronic actuator.
14. Immediately test drive the vehicle for at least 15 minutes to clear any residual product.
